MISCELLANEOUS PAPER S-69-27

# LANDING MAT OVERLAY ON DETERIORATED PAVEMENT

## BARE BASE SUPPORT

U. S. Army Engineer Waterways Experiment Station  
CORPS OF ENGINEERS  
Vicksburg, Mississippi

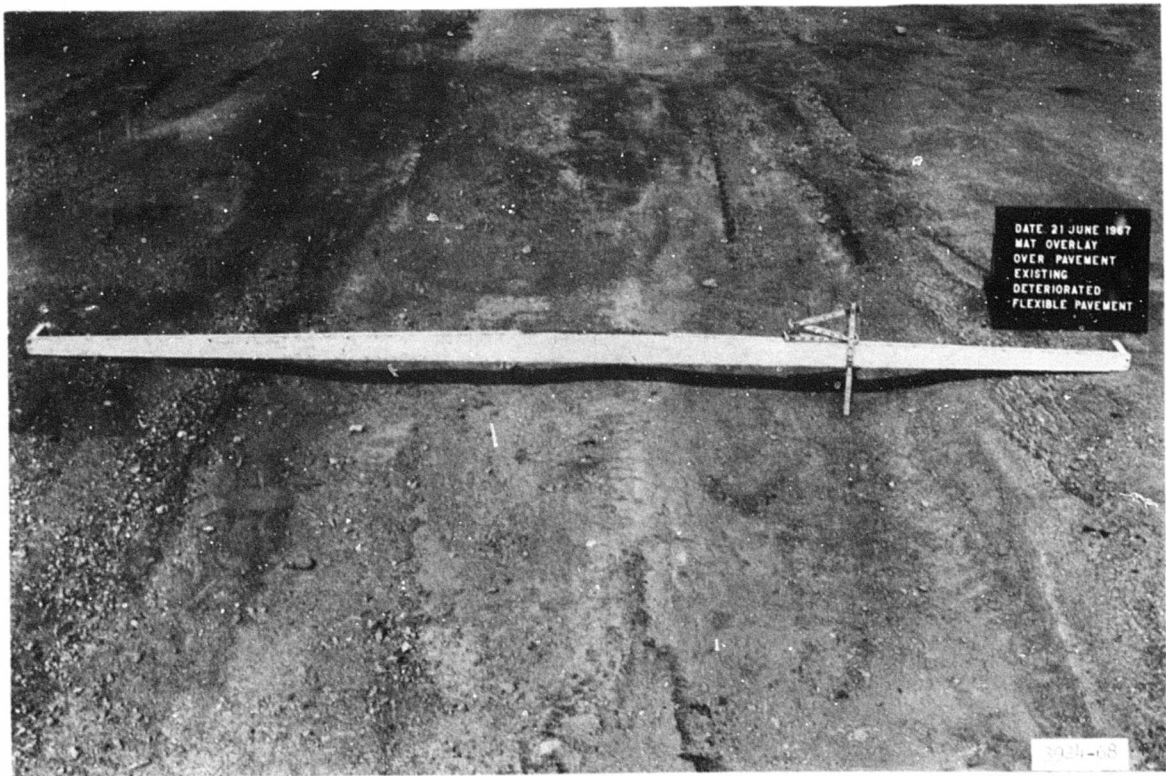
20. A general view of the deteriorated pavement prior to construction of the overlay test section is shown in photograph 3. The area had a continuous slope of about 1.1 percent from south to north (plate 5). A section measuring 180 ft long and 36 ft wide was laid out on the deteriorated pavement and was divided into six test items, each 30 ft long and 36 ft wide. The entire soil overlay was constructed prior to placement of the landing mat.

Photograph 3. Deteriorated asphaltic concrete pavement used for test section

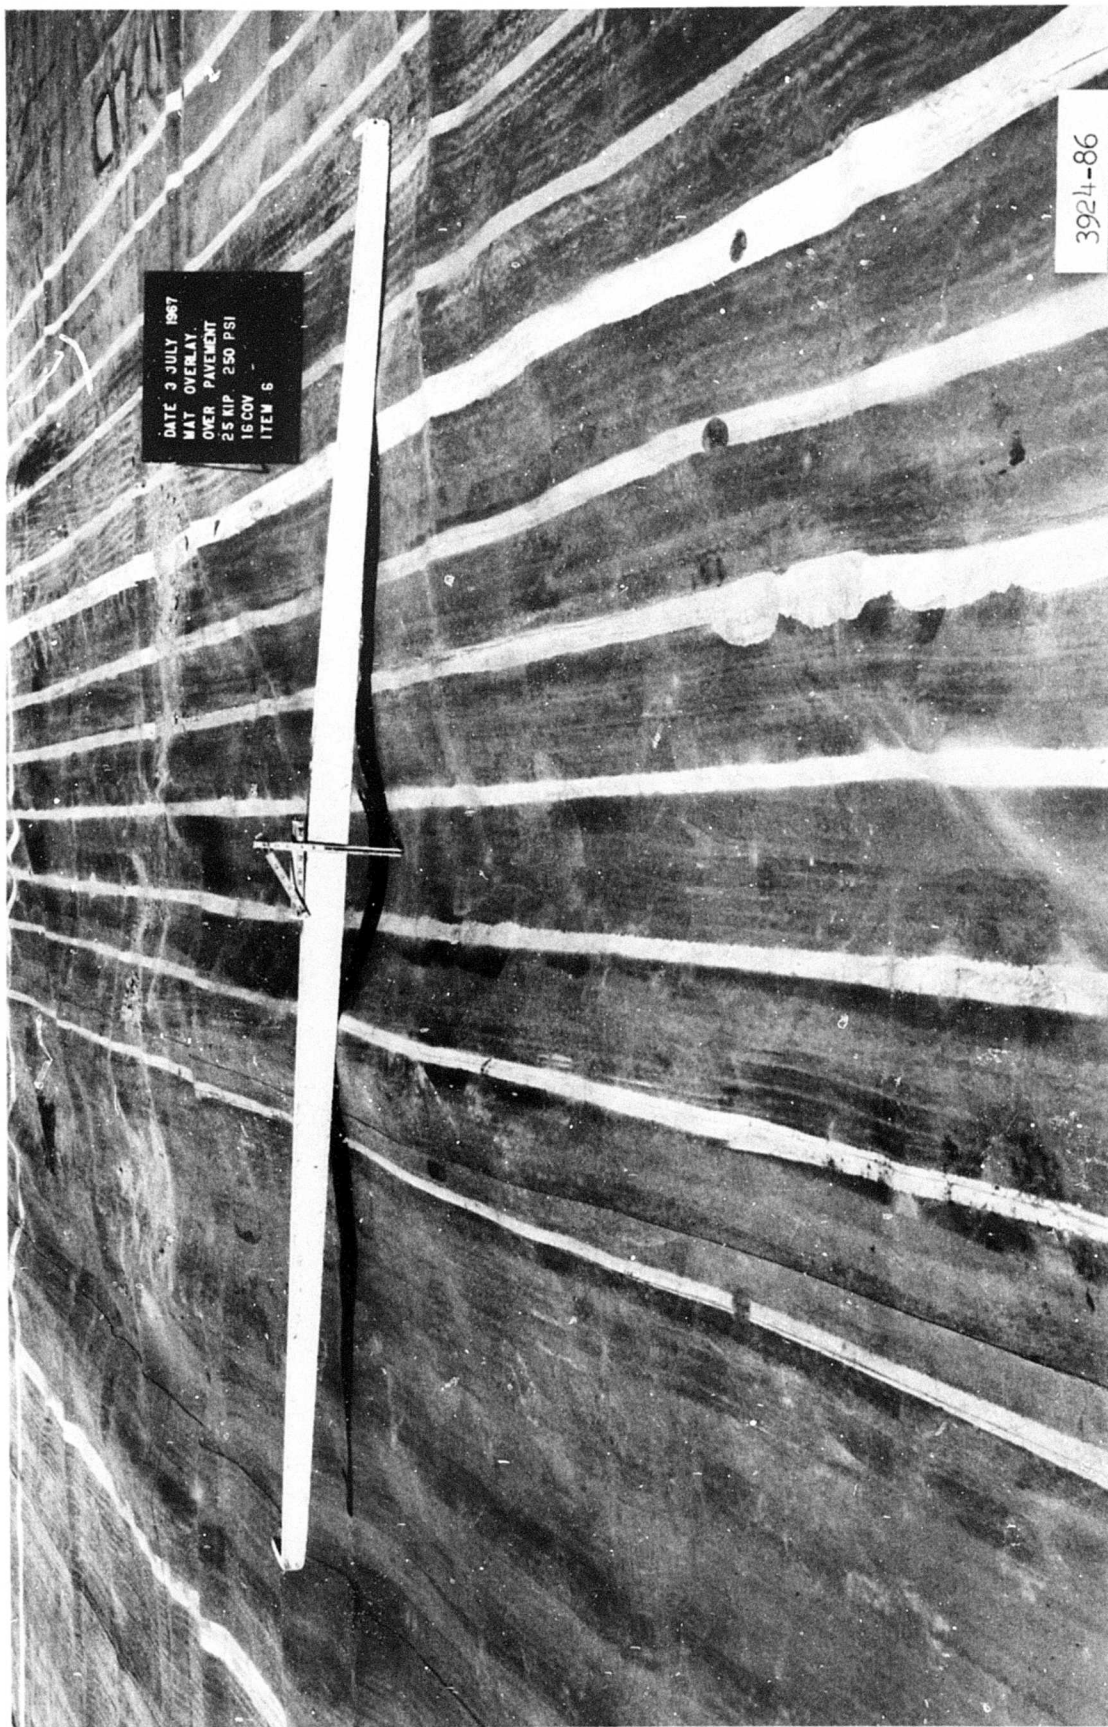
31. Test traffic was begun on 30 June 1967. General views of items 1 through 6 prior to traffic are shown in photographs 10 through 15. Rutting began to develop in item 6 at about 10 coverages. By 16 coverages there was an average rut depth of approximately 2.5 in. as shown in photograph 16. Investigation of the lean clay leveling material revealed that the in-place moisture content was approximately 16.5 percent, which was too high for the compaction effort being exerted by the simulated F-4C test

load. The high soil moisture resulted in the development of pore pressure in the soil under the high-pressure tire traffic with a resultant loss in strength. Therefore, at this stage of the test, it was necessary to remove the WX18 membrane from item 6 and to dry the lean clay soil to a lower water content. The soil was dried back to about 11.5 percent moisture and compacted with 16 coverages of the 50,000-lb roller described in paragraph 23. The compacted clay overlay was then proofrolled with four coverages of the test load vehicle, after which an average surface CBR of 44 was indicated. The compacted clay was then fine bladed with a road grader, the WX18 membrane was replaced on the item and anchored, and the traffic test was resumed.

Photograph 16. Item 6 after failure at 16 coverages

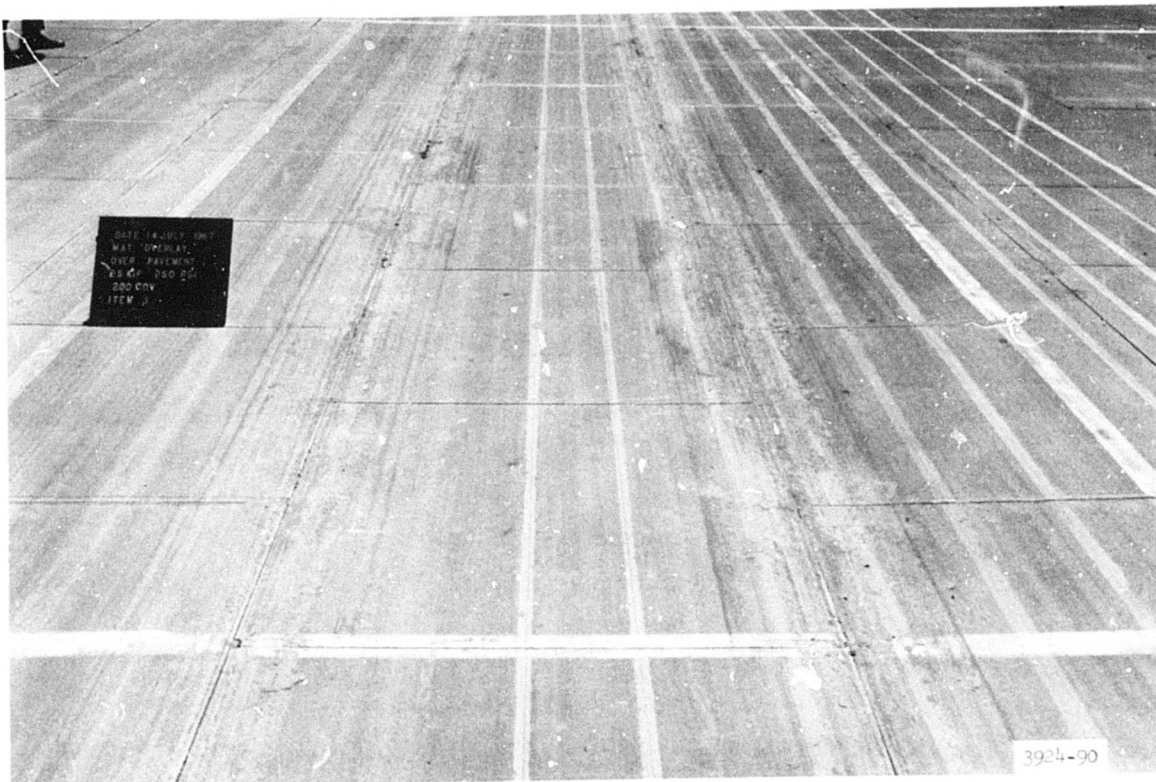
32. On 12 July, 64 coverages of traffic were applied to the test section for a total of 80 coverages. During these 64 coverages, there was a light rainfall in the test area, and it was observed that a slight amount of soil (i.e. the fines in the clay gravel) was pumping up through the mat joints in item 3. The pumping was minor, however, and did not affect the serviceability of the item. The remainder of the test section indicated no signs of soil pumping and was quite serviceable at this time.

Photograph 19. Item 3 after 120 coverages applied during light rainfall (200 coverages total). Note soil pumped onto mat surface

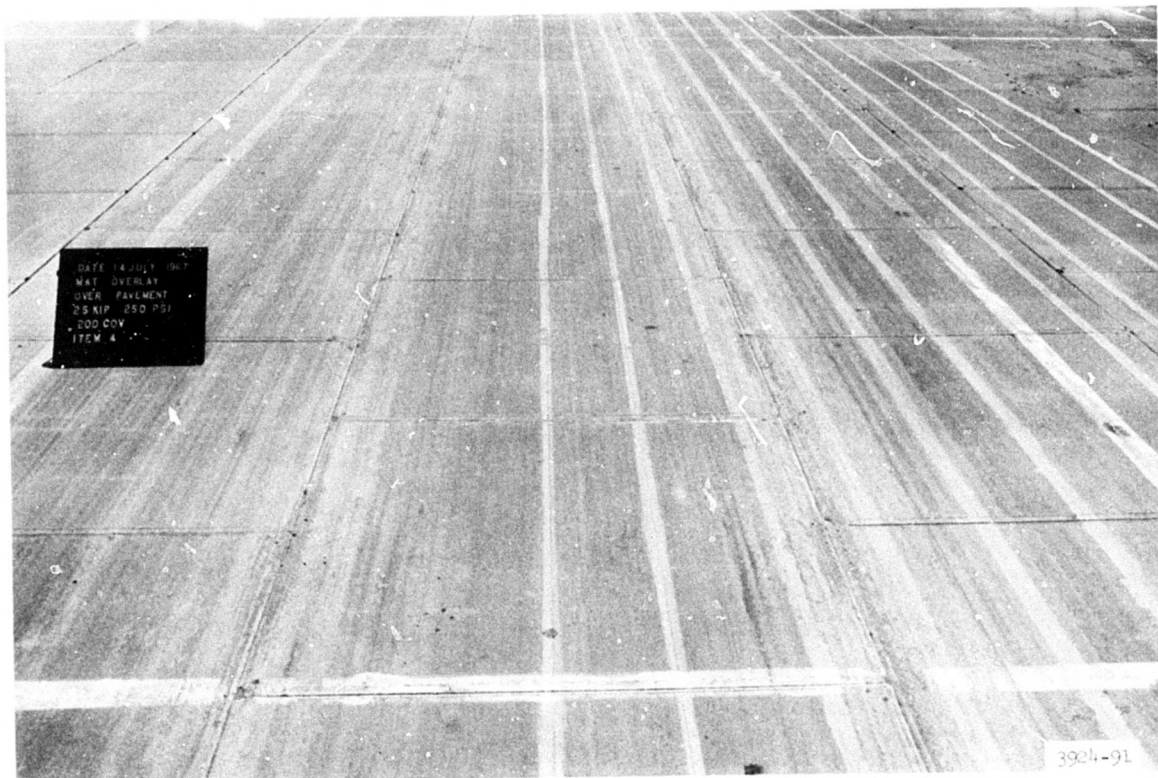
Photograph 20. Item 4 after 120 coverages applied during light rainfall (200 coverages total). Note soil pumped onto mat surface

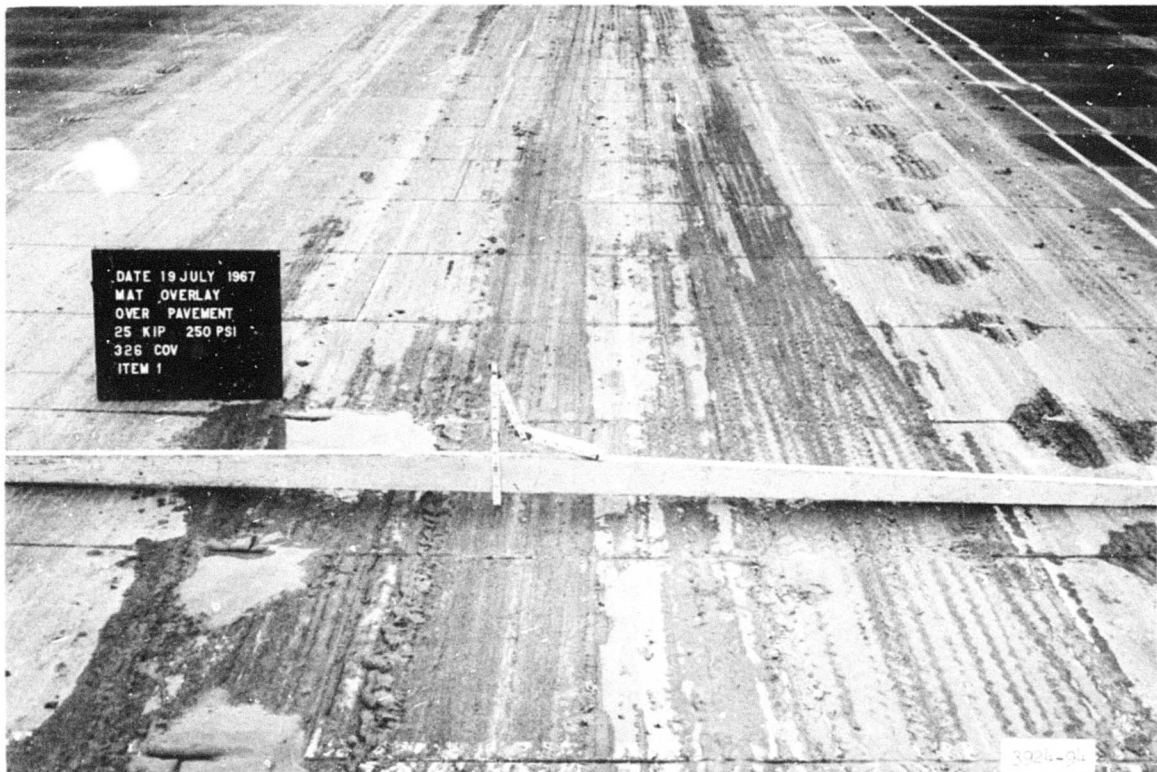
34. From 14 to 18 July, the test section received 100 coverages (total 300) and no difficulties were experienced. On 19 July, 26 coverages were applied during a heavy rainstorm. Severe pumping of the sand in items 1 and 2 and of the clay gravel fines in items 3 and 4 occurred. No soil pumping was observed in items 5 and 6. Views of items 1 through 6 at 326 coverages are shown in photographs 23 to 28, respectively. A close-up of sand pumped through the mat joints between items 1 and 2 is shown in

Photograph 23. Item 1 after 26 coverages applied during heavy rainfall caused severe pumping (326 coverages total)

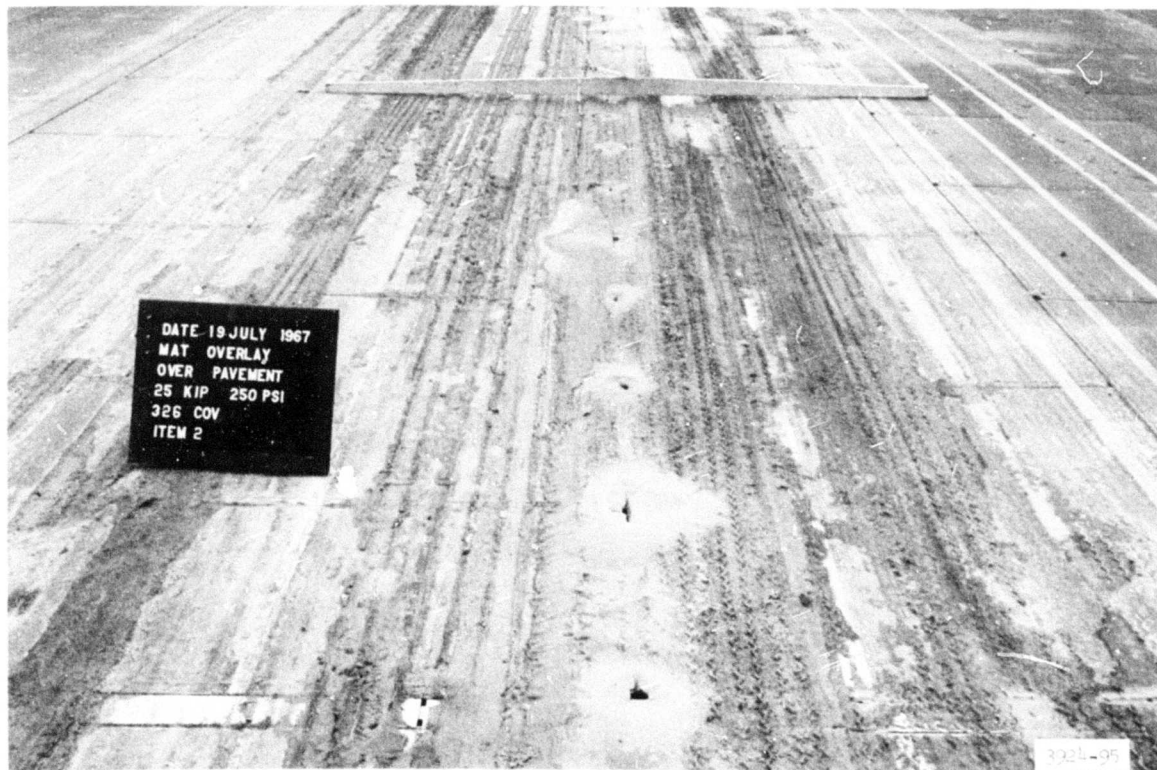
Photograph 24. Item 2 after 26 coverages applied during heavy rainfall caused severe pumping (326 coverages total)

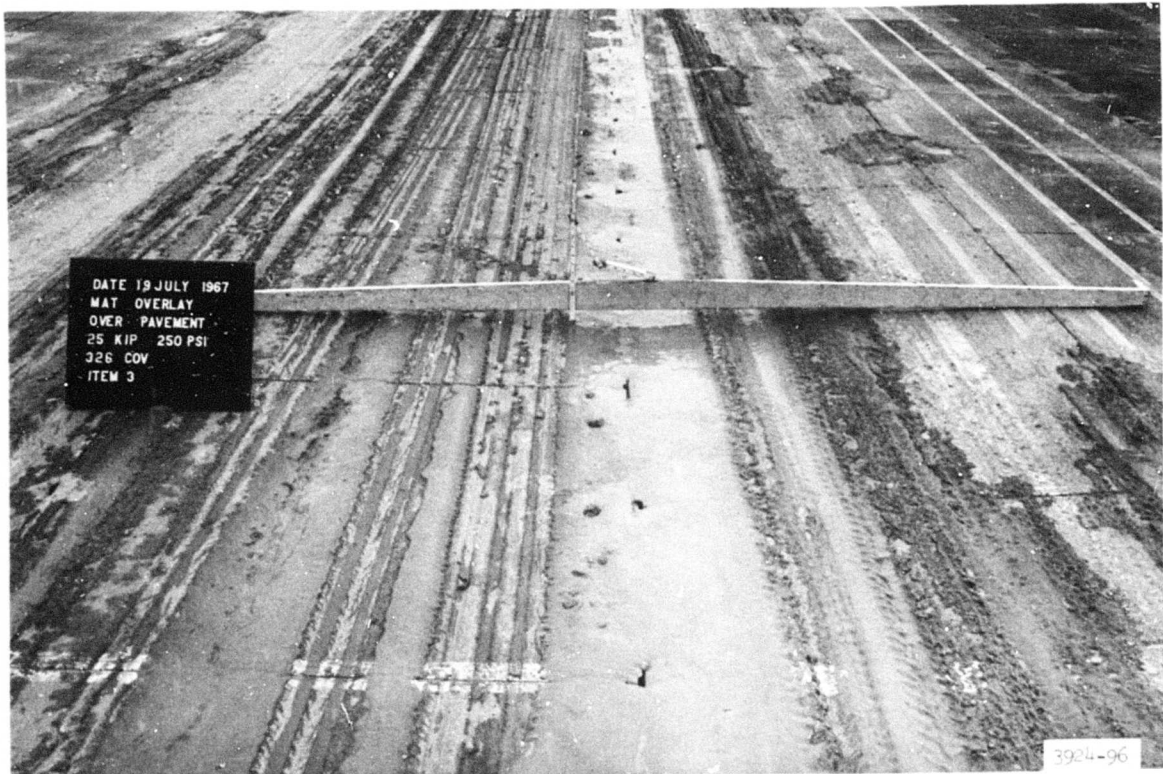
Photograph 25. Item 3 after 26 coverages applied during heavy rainfall caused severe pumping (326 coverages total)

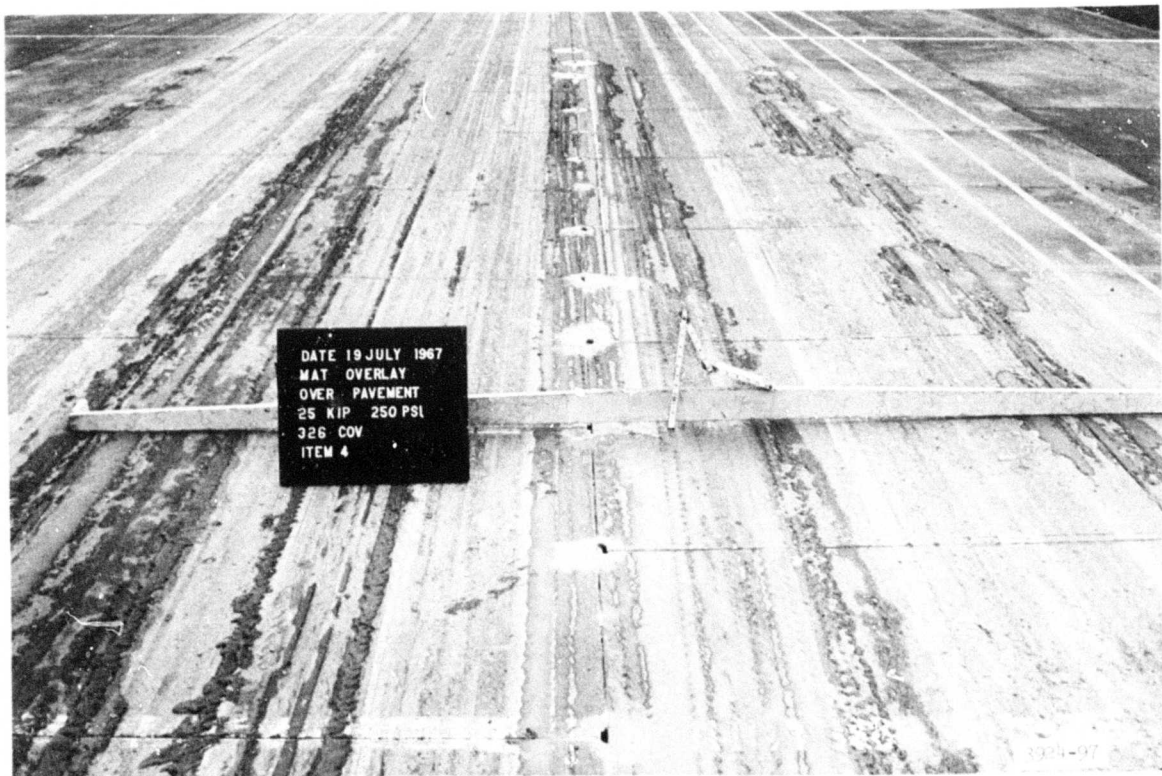
Photograph 26. Item 4 after 26 coverages applied during heavy rainfall caused severe pumping (326 coverages total)

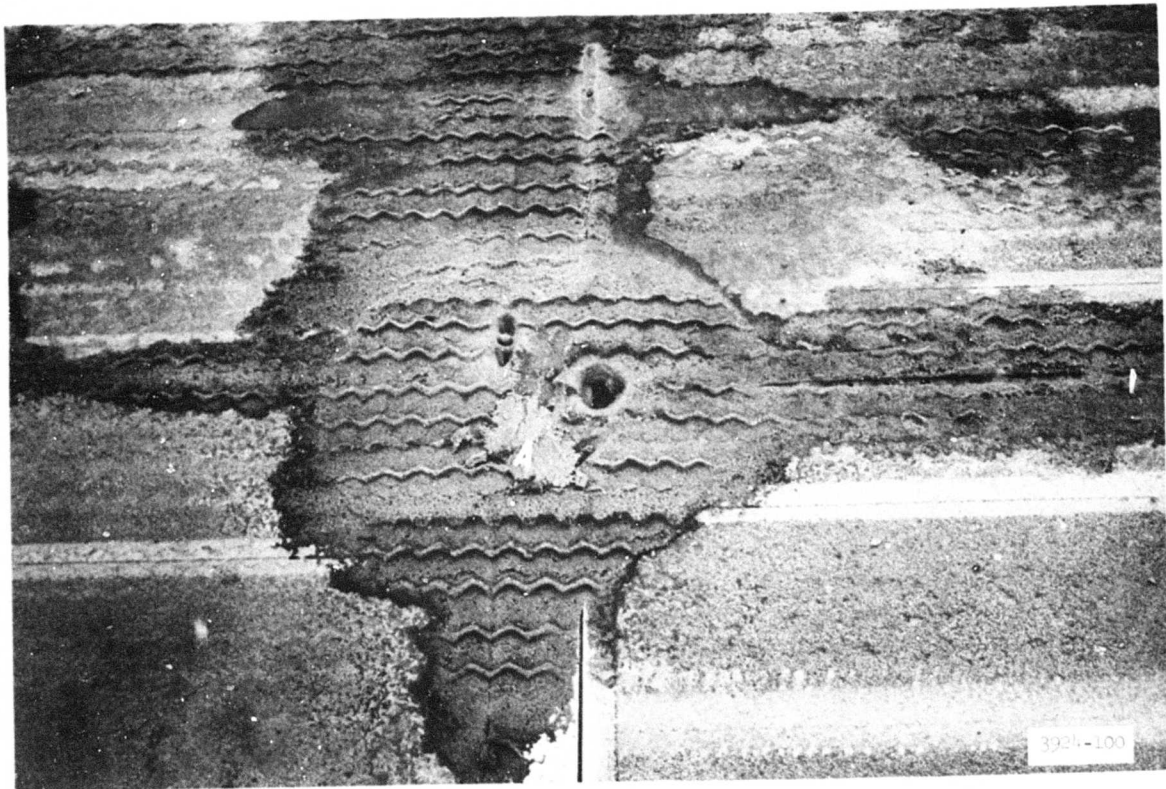
photograph 29. After 330 coverages, it was decided that major maintenance would be required to prevent further deterioration of items 1 through 4; therefore, test traffic was suspended.

Photograph 29. Sand that pumped through the mat joints between items 1 and 2 when section was trafficked during heavy rainfall

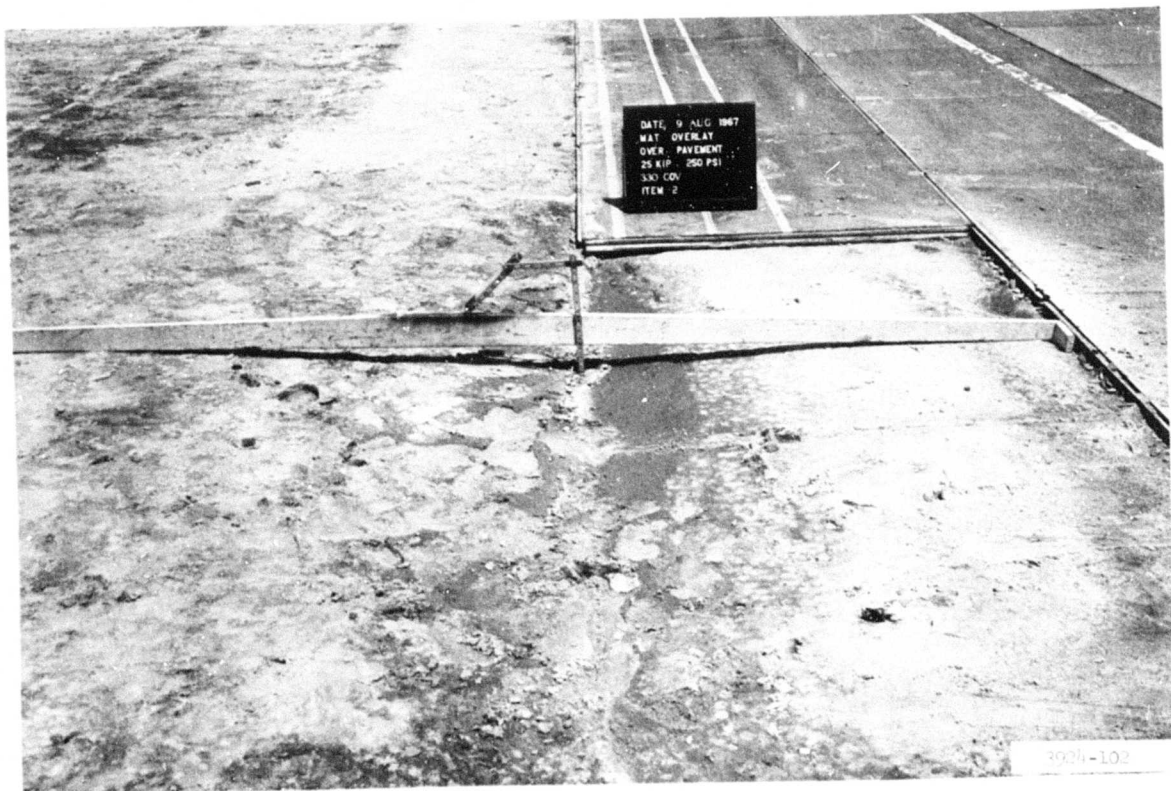
Photograph 30. Condition of sand overlay after 330 coverages

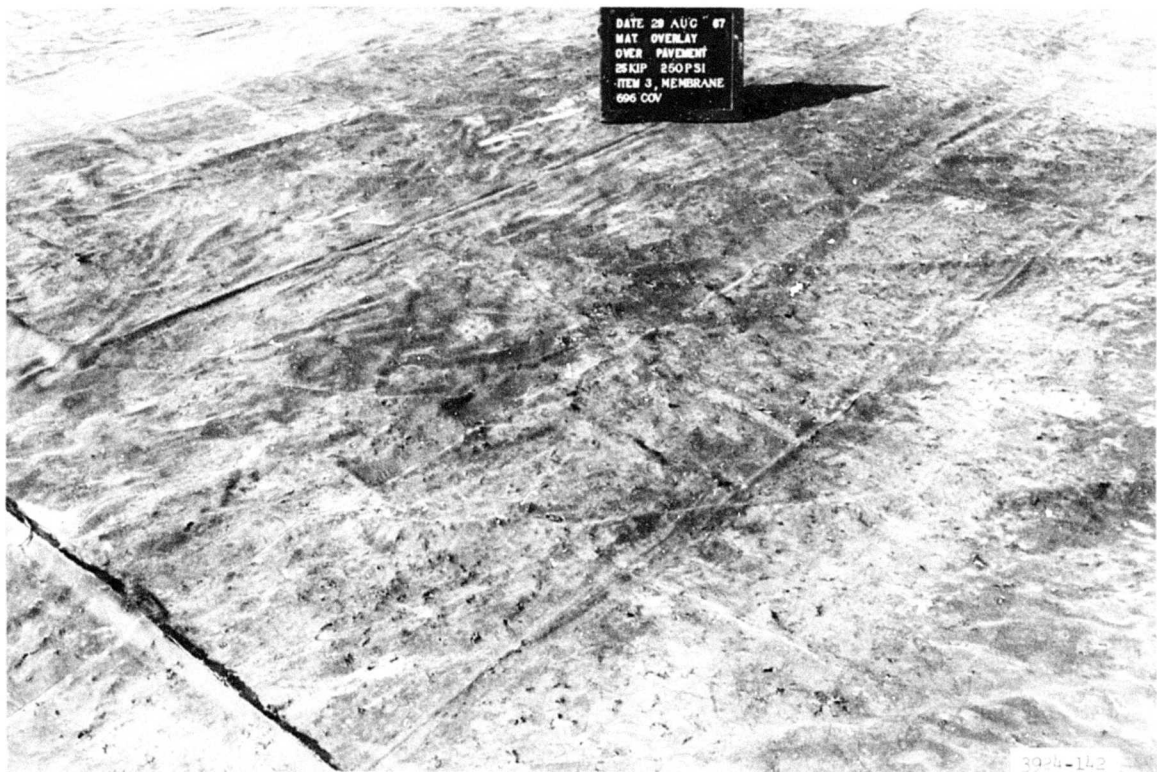
Photograph 44. Numerous holes worn in T16 membrane on item 3 during 366 coverages (696 total coverages on section)

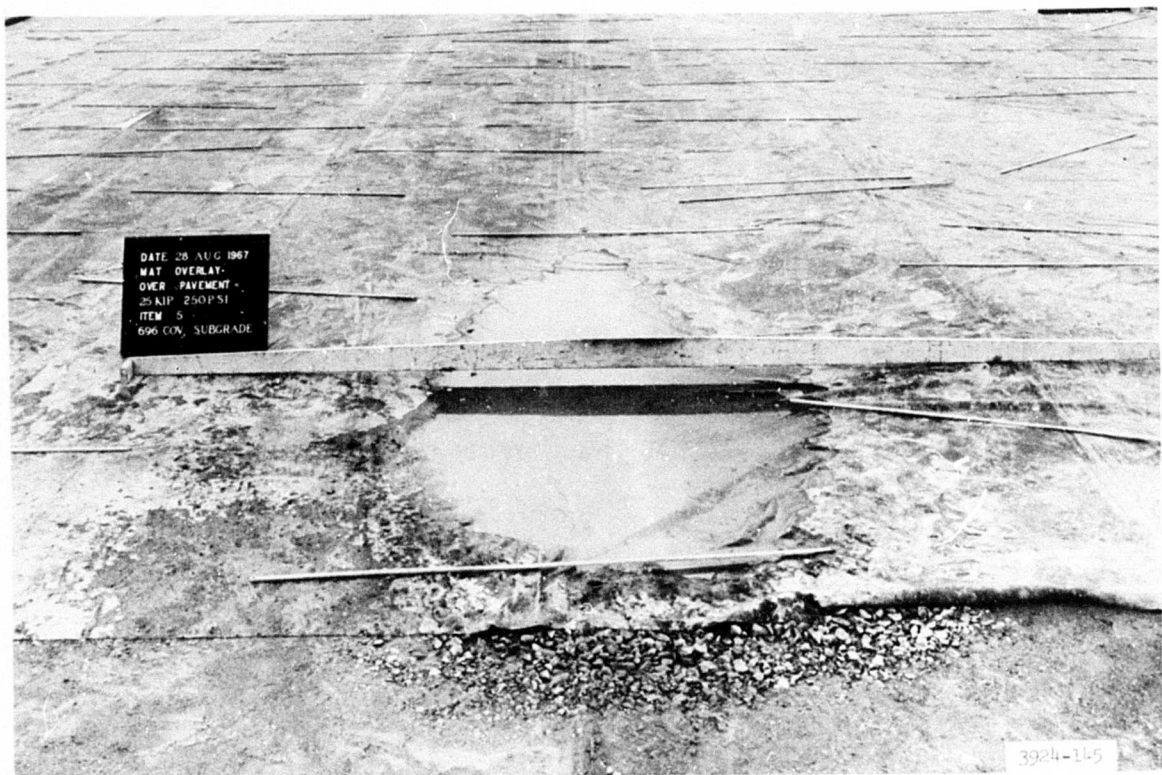
Photograph 46. Washed clay gravel between items 4 and 5 (rods are XM19 connector bars)

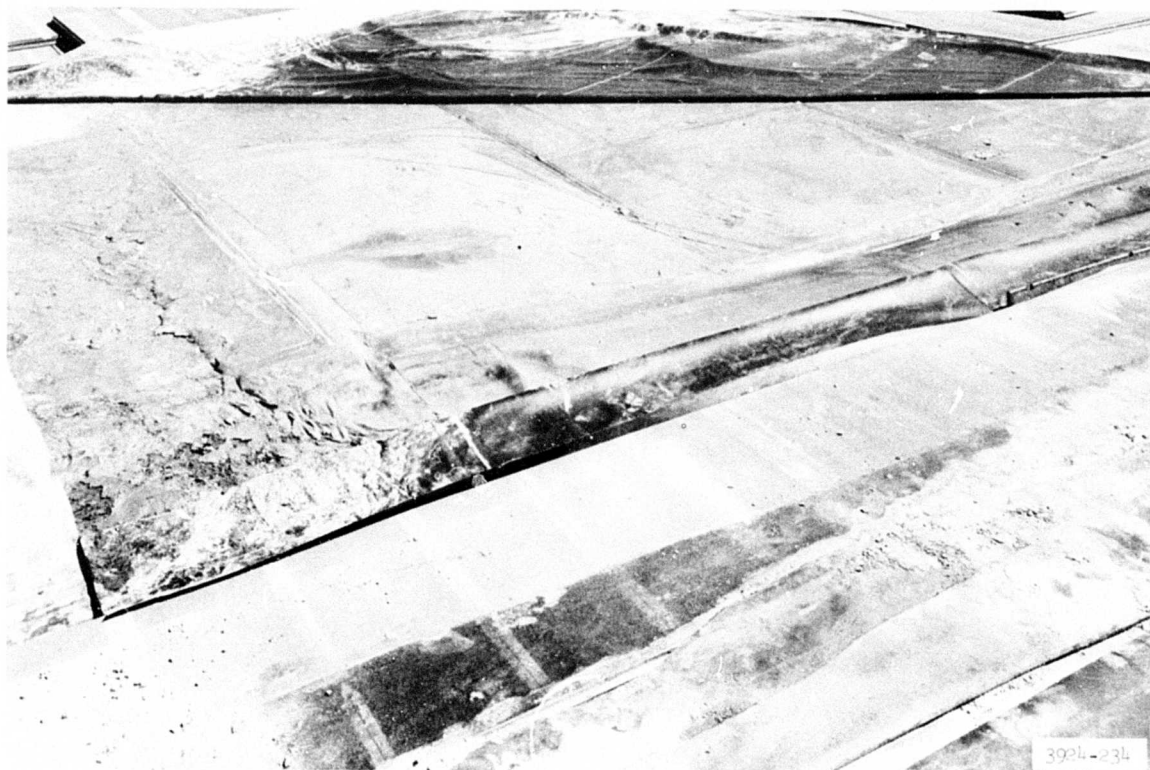
Photograph 51. Condition of soil under failed panel of XM19 (1850 coverages)

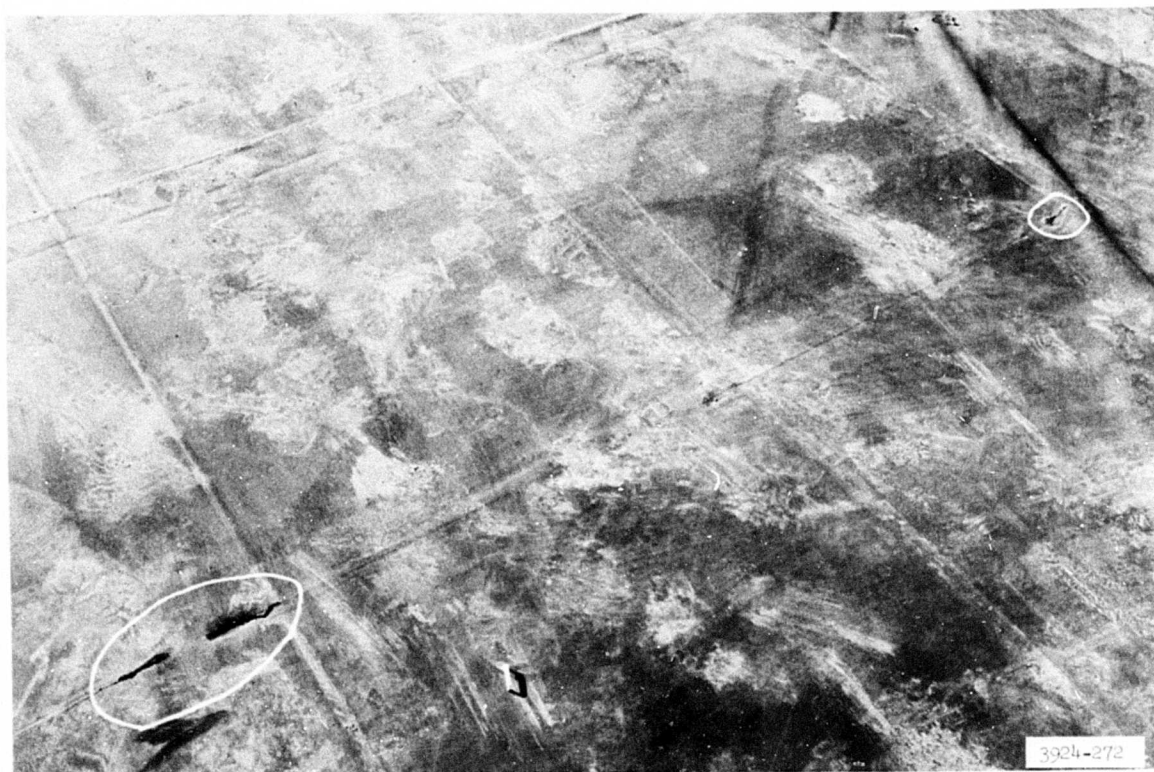
48. All mat was removed from the test section. Inspection of the test section revealed that the continual movement of the individual mat planks during trafficking had caused a pinching action on the Tl6 membrane directly below the mat joints in items 1 and 2. The pinching had cut the membrane in several locations, which allowed water to enter the sand and cause subsequent pumping. Closeup views of the result of the pinching action of the mat in items 1 and 2 are shown in photographs 57 and 58, respectively. The soil pumping had not been particularly severe, and as shown in photographs 59 and 60, the underlying sand was still relatively smooth and stable. An examination of the WX18 membrane in item 3 revealed that the WX18 fared little better than the Tl6 membrane when exposed to the abrasive action of the mat and clay gravel. Photograph 61 shows that numerous holes were worn in the WX18 membrane.

Photograph 57. Membrane cut by pinching action of mat in item 1

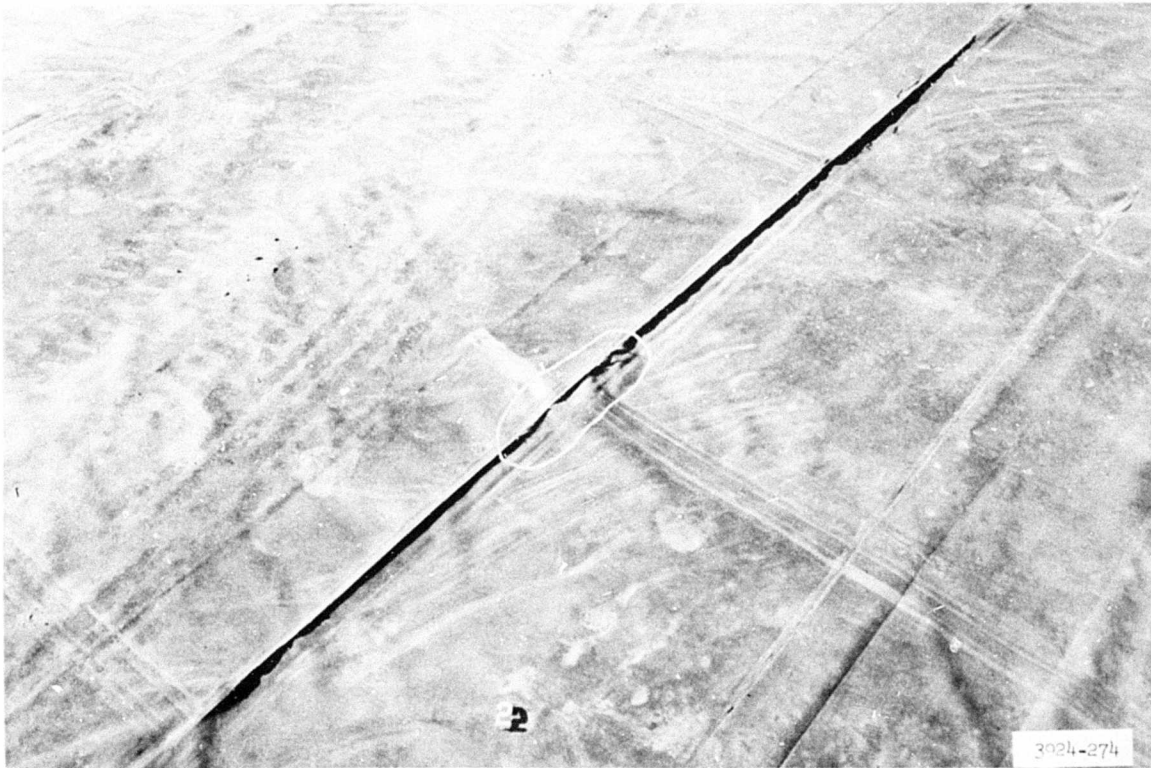
Photograph 58. Membrane cut by pinching action of mat in item 2

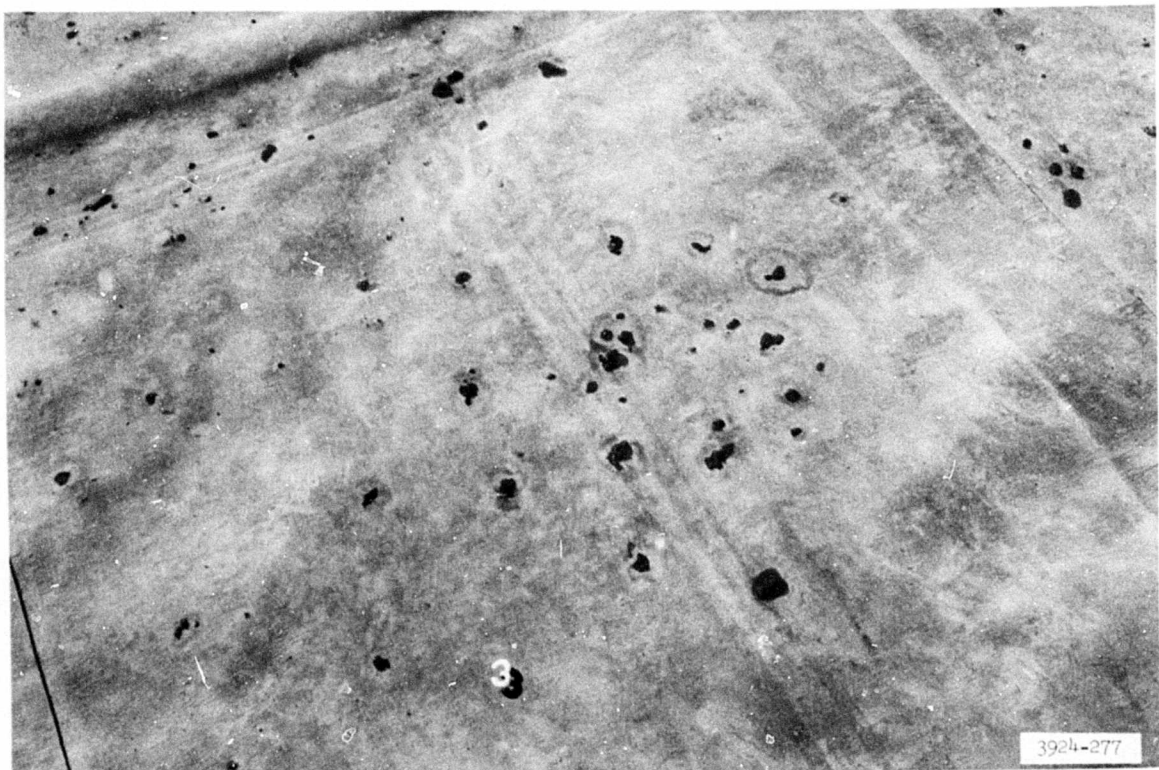
Photograph 61. Holes worn in WX18 by abrasive action of mat and clay gravel

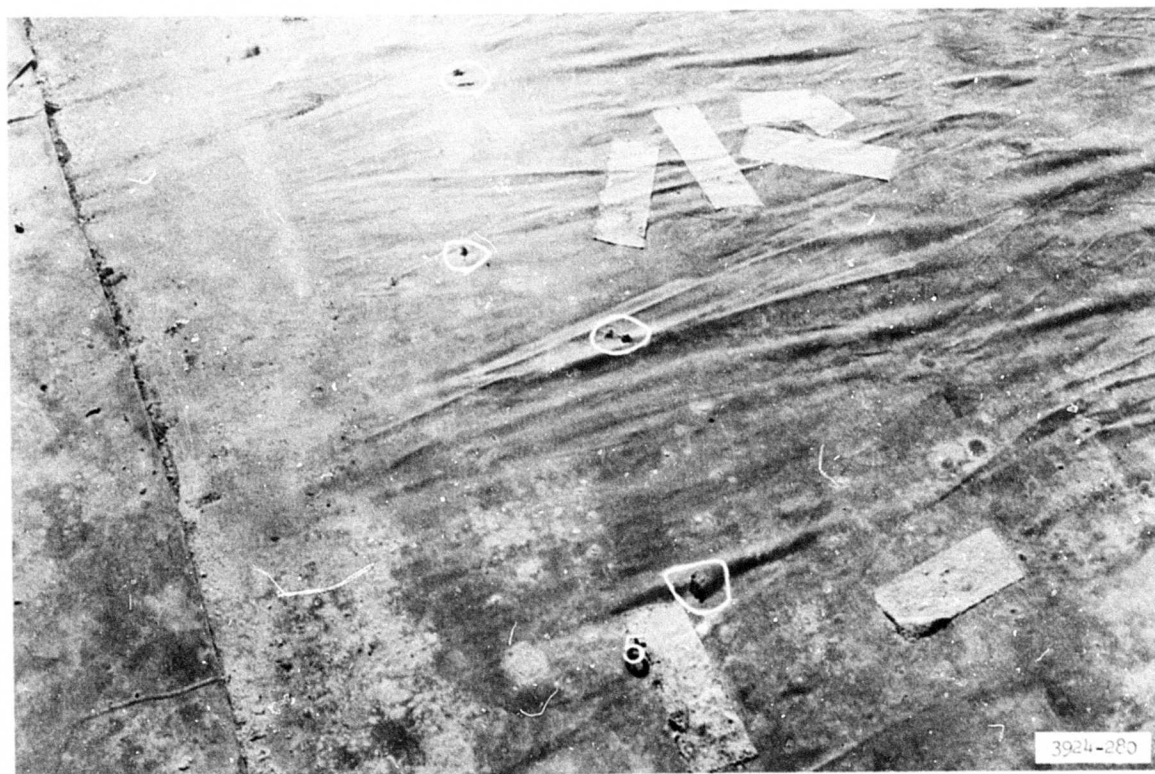
50. Examination of the Tl6 in item 5 after removal of the mat revealed that, generally, the membrane had remained intact throughout the test. In a small area near the transition to item 4, it was found that several small holes had been cut in the membrane due to point abrasion of the membrane on pebbles and small rocks between the membrane and hard soil surface during traffic (see photograph 63). The exposed lean clay in the area directly below the location of the holes in the Tl6 is shown in photograph 64. It can be seen from the heel prints on the soil that the lean clay had become wet in this particular area. Soil tests in this area indicated an average surface strength of about 3.2 CBR.

Photograph 63. Small holes cut in T16 membrane in item 5

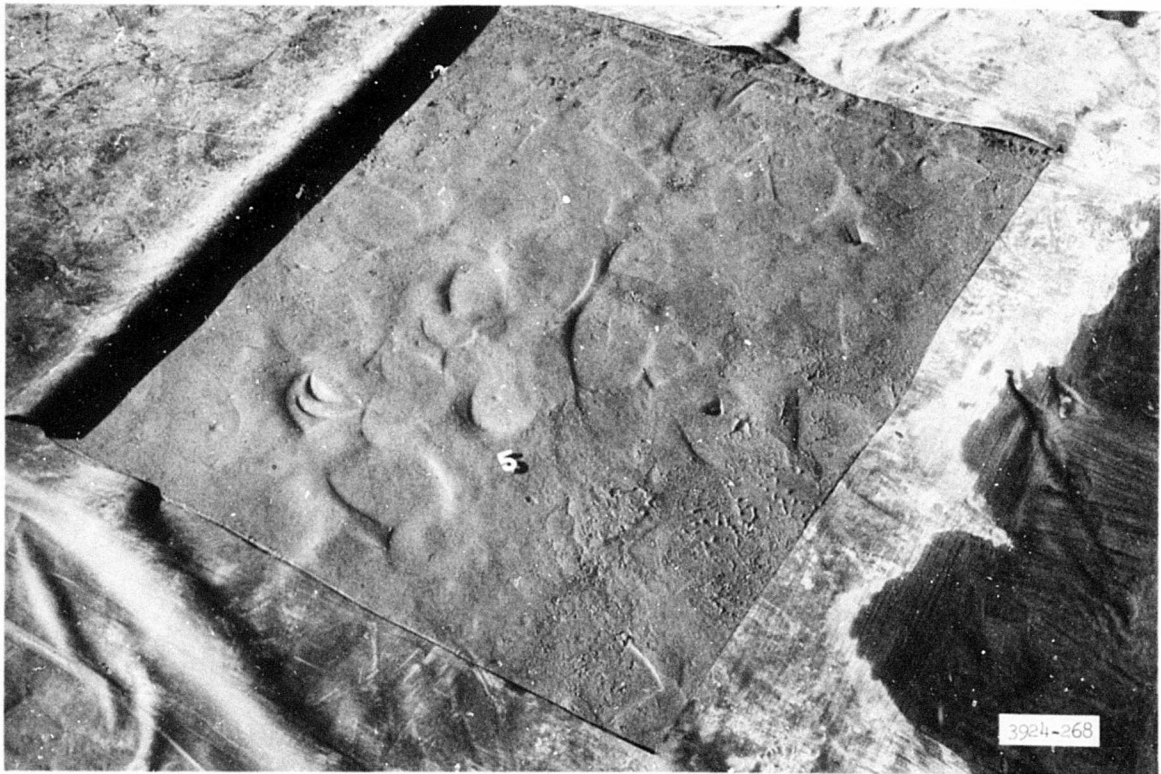
Photograph 64. Lean clay directly under holes shown in photograph 63

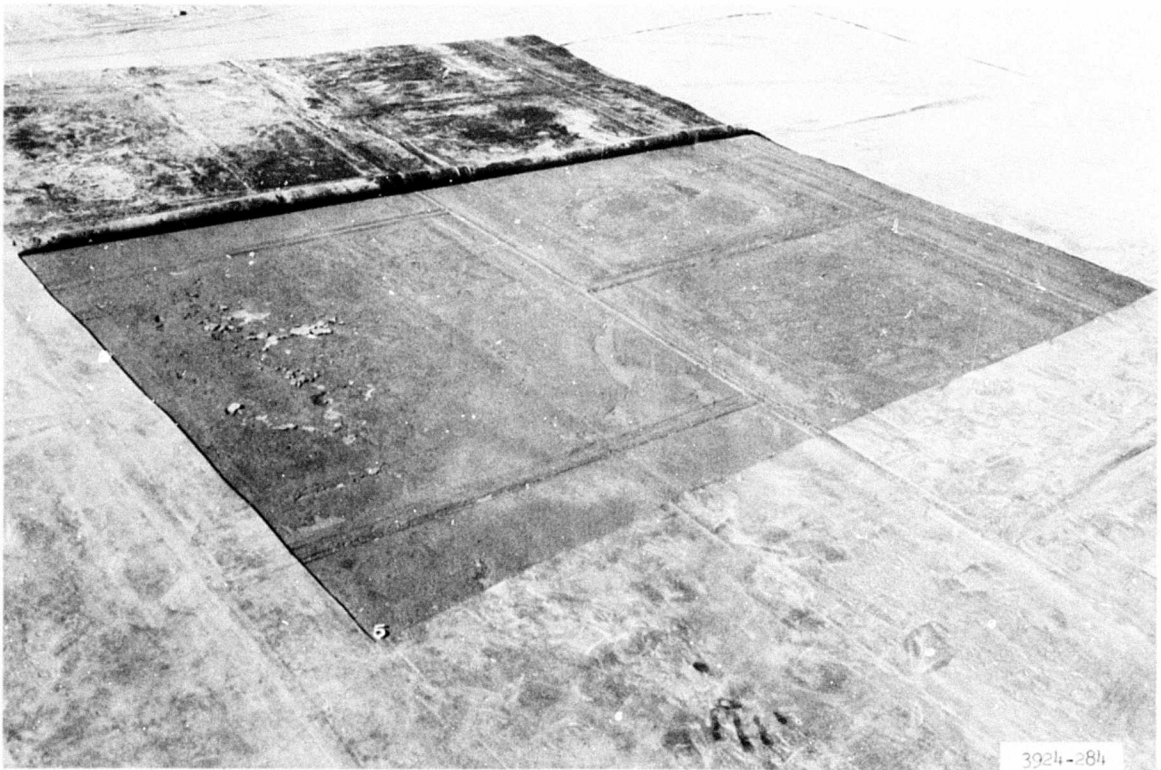
51. Overall, the condition of item 5 was good. During trafficking there had been no evidence of soil pumping or surface deformation. An

exposed area of the lean clay considered to be typical of the item is shown in photograph 65. The top 1/8 to 1/4 in. of soil was moist due to condensation under the membrane; however, the underlying material was quite dry and hard. Soil tests in this area indicated soil strength below the moist zone to be about 49 CBR.

Photograph 65. Stable condition of lean clay considered typical of item 5

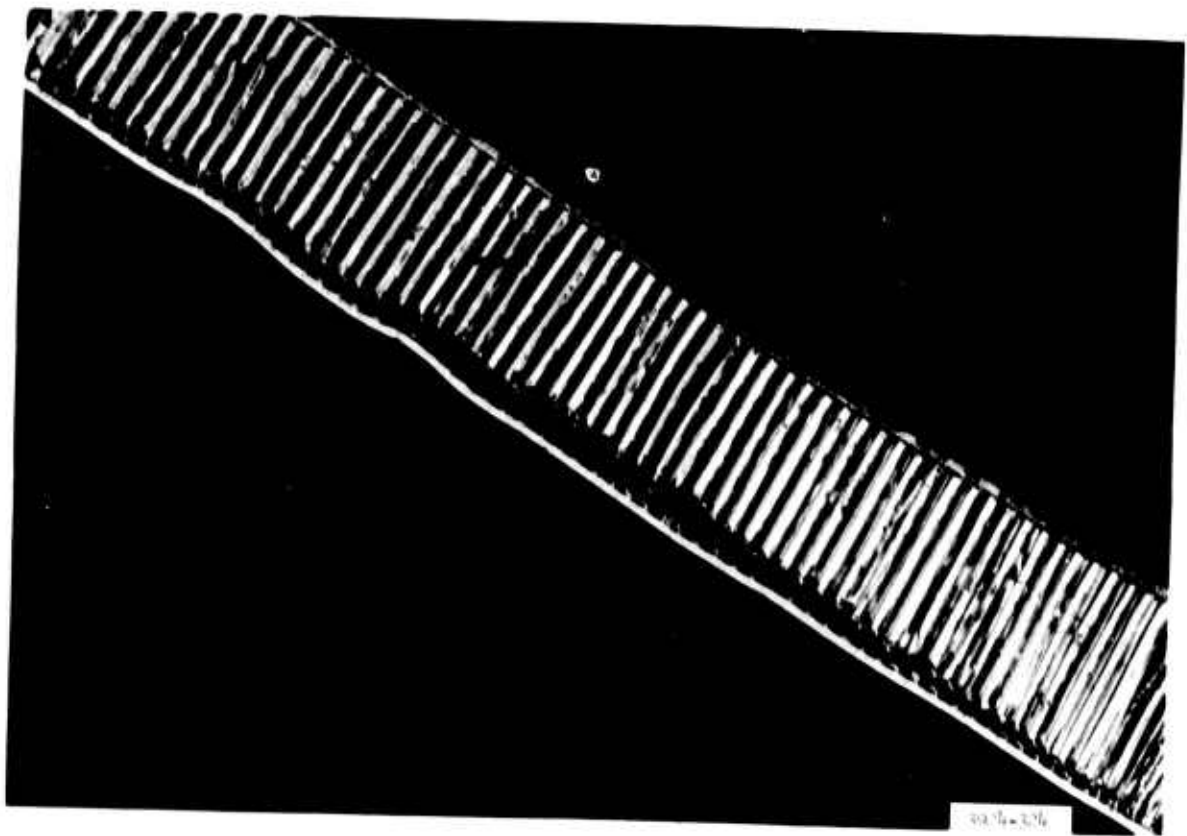
61. One point that should be emphasized at this time is the performance of the XMl9 mat on the clay gravel. During the latter part of the test, it was observed that a number of panels in items 3 and 4 had developed shallow depressions 4 to 8 in. in diameter in the upper surface, which indicated that core failure was developing in these areas. Upon removal of the mat after testing was completed, it was found that the panels had been subjected to point loading in areas of contact between the mat and the larger aggregate in the clay gravel. This was evident from the numerous indentations found on the underside of the panels after their removal from the clay gravel items (see photograph 67). The results of this point loading were localized failures of the mat core that progressed to form large depressed areas. Photograph 68 shows a cut section of mat in an area where a surface depression had

developed. It can be seen that the lower part of the internal core had failed and separated from the panel skin.

Photograph 68. Internal failure of XM19 mat
